# Manhole Inspection Summary

Manhole # S23KK1019MH

Insp Date: **7/15/07 12:25 AM**

**Location** Address: **COLD SPRING LN**

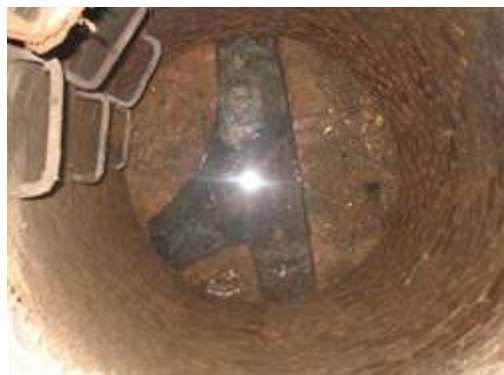
Top View

Corroded steps. Evidence of surcharge - Bench debris. Channel debris.

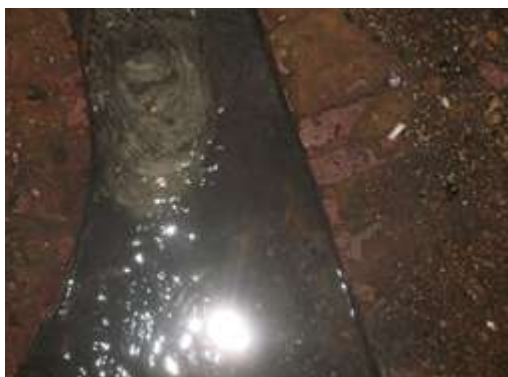
Defect

Channel debris.

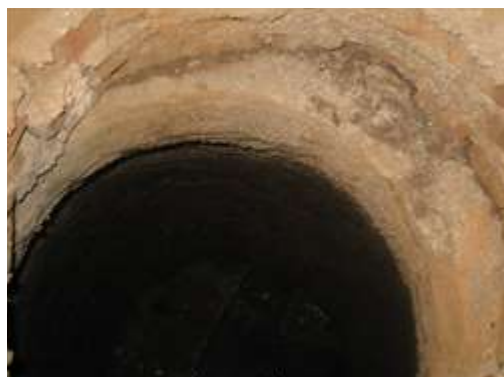
Defect

Frame offset.

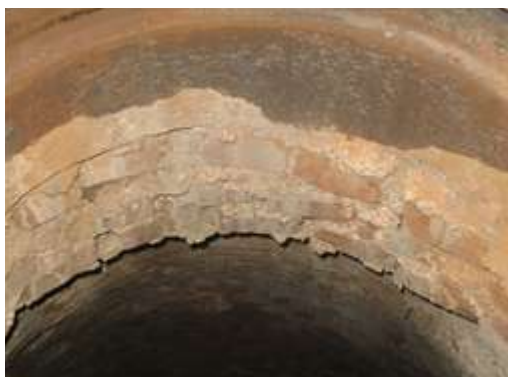
Defect

Frame leaks. Adjustment deterioration and infiltration. Corbel and Barrel infiltration.

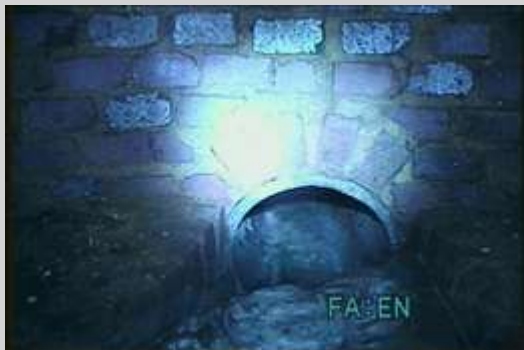
### 10 in. Circular Gravity Sewer Pipe Out @ 12 O'Clock

Deposits: ☐ None ☐ Mud ☐ Sludge ☒ **Debris** ☐ Grease

Silt Depth: **4** (in.) Deposits Extent: **Heavy**

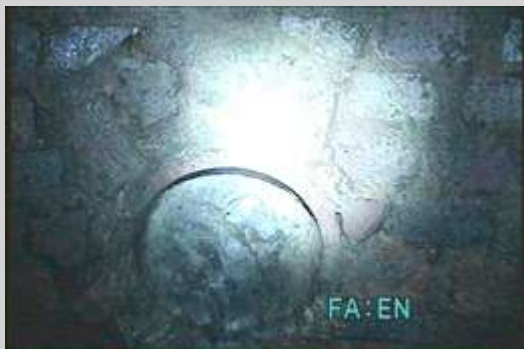
### 8 in. Circular Gravity Sewer Pipe In @ 6 O'Clock

Deposits: ☐ None ☒ **Mud** ☐ Sludge ☒ **Debris** ☐ Grease

Silt Depth: **2** (in.) Deposits Extent: **Medium**

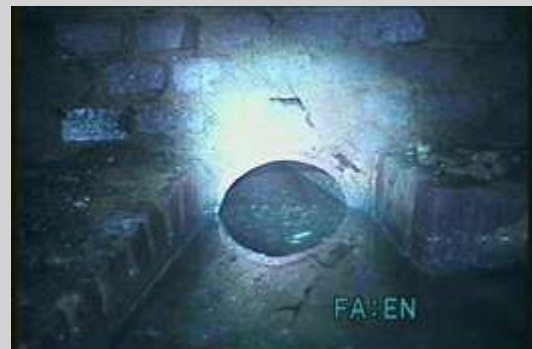
### Drop In @ 6 O'Clock

Drop Condition: **Clogged**

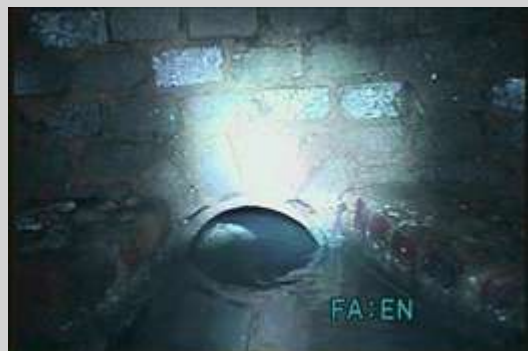
Pipe In @ 8 O'Clock

Deposits: ☐ None ☐ Mud ☐ Sludge ☒ **Debris** ☐ Grease

Silt Depth: **3** (in.)

Deposits Extent: **Medium**

Infiltration: **Evidence**

Pipe Seal Cond: **Cracked**
